YC:	TOP SECRET	CIÆ	Z37 A/PIR-71011
· [	Approved For Release 2006/02/07 : CIA-RDP02T06408R001200010014-2		•
-		25X1	
-	IMAGERY ANALYSIS DIVISION		
-			1
-	ANTISATELLITE/SPACE TRACKING RADAR COMPLEXES		
-	MISHELEVKA AND SARY-SHAGAN, USSR		
-			25X
-			
-

OCTOBER 1966

CENTRAL INTELLIGENCE AGENCY

PHOTOGRAPHIC INTELLIGENCE REPORT

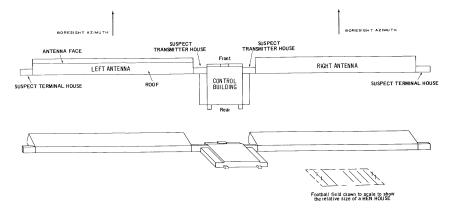
FIGURE 2. PERSPECTIVE VIEW OF A DUAL HEN HOUSE RADAR WITH TERMINOLOGY ANNOTATIONS.

It is believed desirable to clarify certain nomenclature and terminology previously used. This is shown in Figure 2. Inasmuch as the mass of the control building is positioned to the rear of the antenna face, it is considered reasonable to use the words front and rear with respect to the control building and the associated HEN HOUSE structures. Assuming a front facing situation, the HEN HOUSE antenna structures have been designated right and left.

To permit an appreciation of the size of these structures, Figure 2 shows a perspective view of a THIN BOY Dual HEN HOUSE Radar and, drawn to the same scale, an American football field.
